# **SUNFLOWER POWER CONVERSION SYSTEM**

**QUARTERLY REPORT**

**MARCH 1963 – MAY 1963**

**TAPCO** a division of  
*Thompson Ramo Wooldridge Inc.*

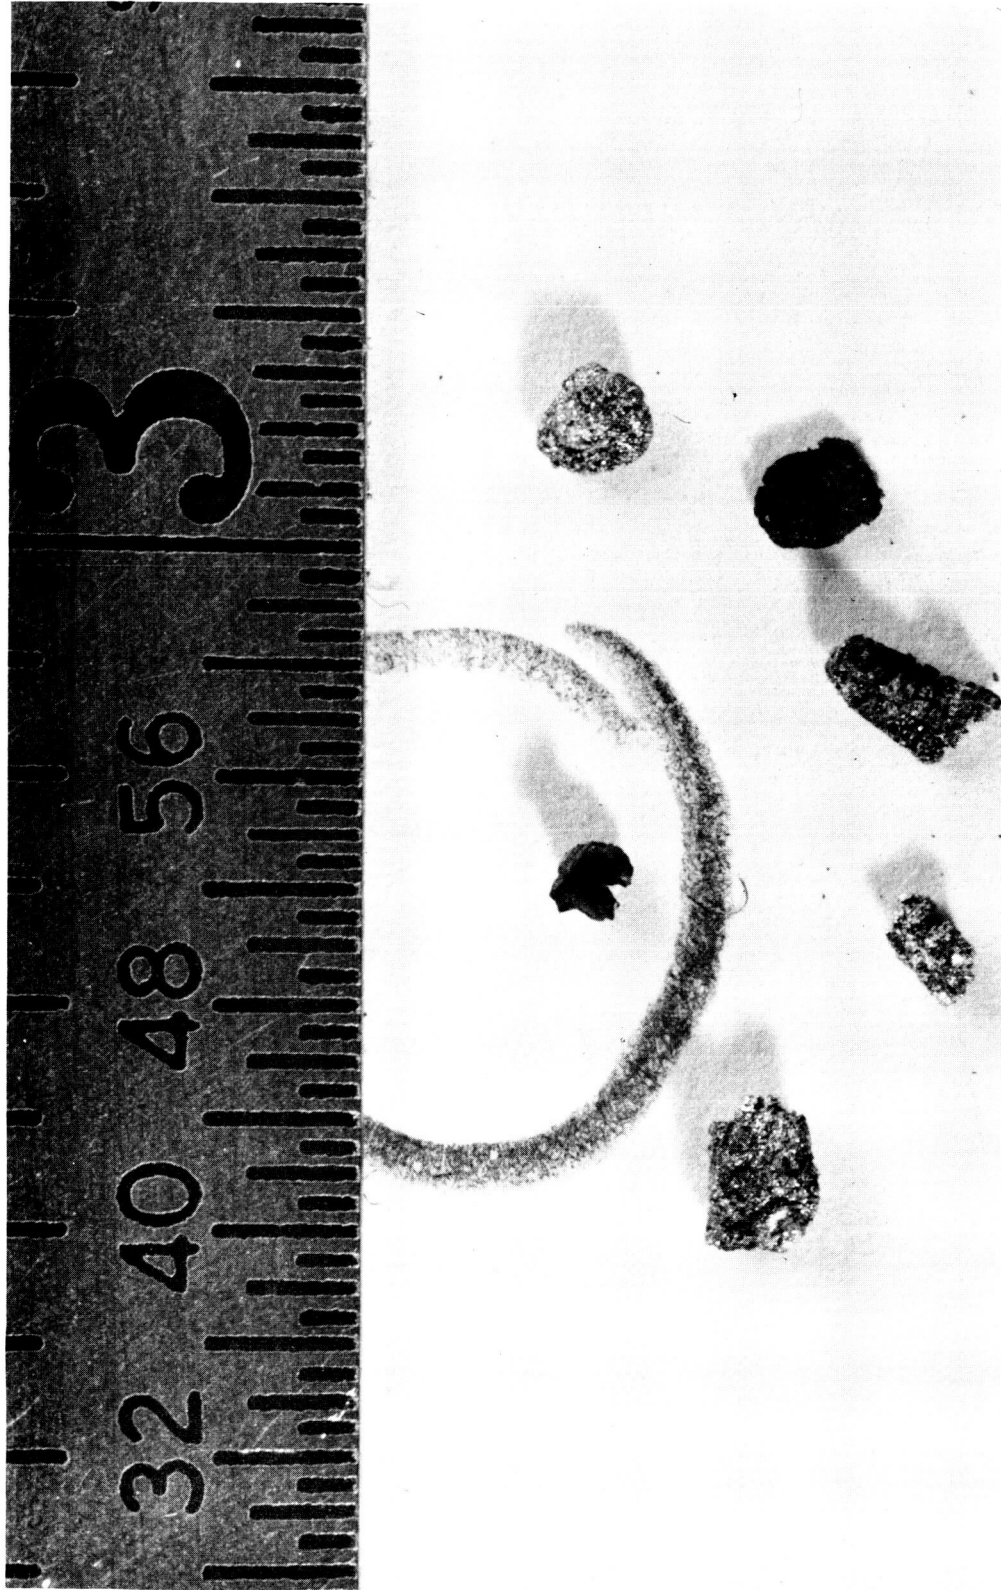
Turbo-alternator CSU I-3A accumulated 768 hours of continuous endurance testing before being voluntarily shut down when foreign particles entered the first stage nozzle from the component test rig. During the last few hours of operation, step changes in power output were observed with subsequent reduction of flow in the test rig. The frequency to which the step changes occurred increased with time and the unit was therefore voluntarily shut down. Post test examinations of the turbine inlet housing, combined with the actual operating conditions of the unit, suggested that particles sufficiently large to block the throat area of the first stage nozzle had entered the turbine housing. This has been confirmed. Figure 9 shows a random sampling of particles removed from the first stage nozzle. This phenomena had not been seen previously in operation of any other units.

Subsequent review of the test rig data indicates that a shut down of the test rig prior to installation and initiation of CSU I-3A test resulted in back flowing mercury from the boiler, up through a centrifugal separator, into the discharge of the superheater, and to an area in front of the metering and shut-off valves at the CSU turbine inlet. These two valves revealed two distinct types of corrosion product deposition. The metering valve located in front of the turbine nozzle showed a very definite vapor deposition of products in a thin layer on the stem of the metering valve. The emergency shut-off valve, however, experienced corrosion products which are believed to have been formed by corrosion products floating on the surface of the mercury during this inadvertent back flush, with subsequent evaporation of the mercury leaving the relatively hard chrome and nickel deposits which were observed. Subsequent operation of the test rig with the CSU then eroded and dislodged portions of these deposits, which were carried down stream into the turbine housing. This caused the step changes in power. As a result of the formation of these particles, several changes in the concept of the test rig have been incorporated. These attempt to prohibit the formation of products on the metering shut-off valves and to include a filter in the turbine inlet line to prevent passage of this size of particles through the plumbing into the unit. These details are explained more fully in the test rig section of the report.

PARTICLES LODGED IN CSU I-3A TURBINE HOUSING
